Manhole Inspection Summary

Manhole # S47CC_006MH

Location Address: **2202 Ashland Ave.** Cross Street: **N. Collington Ave.**

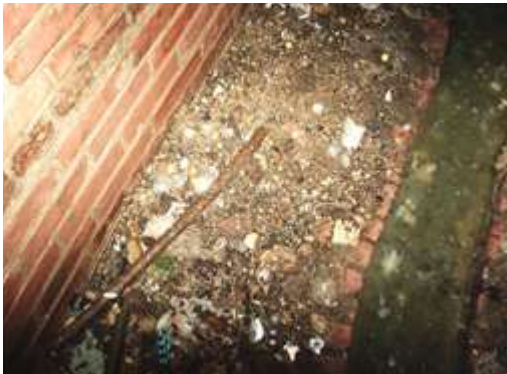
Defect 4

Bench ☒ Exists Material: **Brick** ☐ Parged
Condition: ☐ Sound ☐ Cracked ☐ Root Intrusion ☐ Deteriorated ☐ Leaks ☒ **Debris**

debris

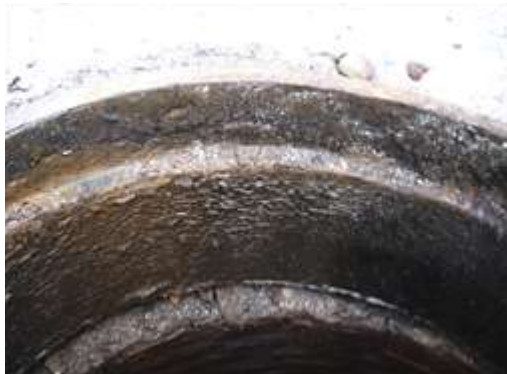
Defect 3

Frame Offset: **1** (in.) Condition: ☐ Sound ☒ **Cracked** ☒ **Leaks**

frame leaks

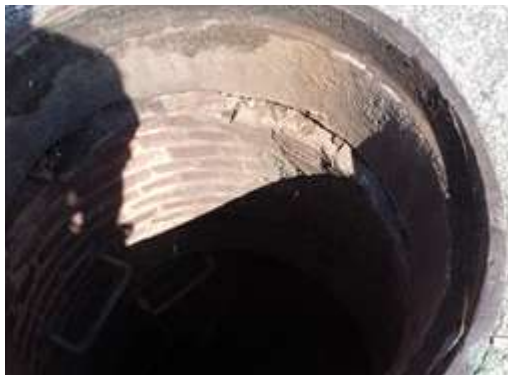
Defect 2

infiltration

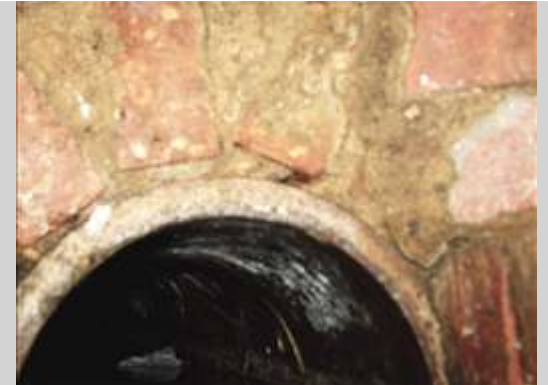
12 O'Clock Outflow

8 in. Circular Gravity Sewer
Pipe Out @ 12 O'Clock

Pipe Height: **12** (in.) Rod and Bar (Angled)
Pipe Material: **Clay** ☐ Pipe Lined
Invert Depth: **8.83** (ft.) Flow Characteristics: **Slow**
Deposits: ☒ None ☐ Mud ☐ Sludge ☐ Debris ☐ Grease
Silt Depth: (in.) Deposits Extent:
Infiltration: **None** Pipe Seal Cond: **Sound**

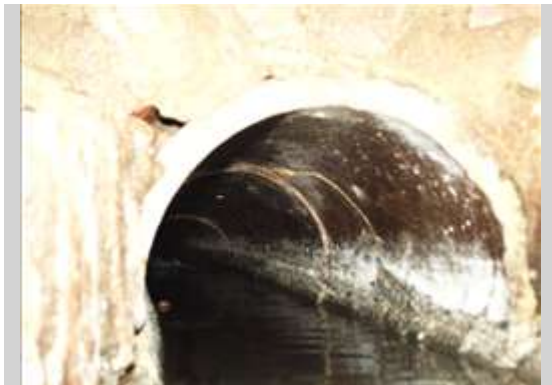
3 O'Clock Inflow

8 in. Circular Gravity Sewer
Pipe In @ 3 O'Clock

Pipe Height: **12** (in.) Rod and Bar (Angled)
Pipe Material: **Clay** ☐ Pipe Lined
Invert Depth: **8.67** (ft.) Flow Characteristics: **Slow**
Deposits: ☒ None ☐ Mud ☐ Sludge ☐ Debris ☐ Grease
Silt Depth: (in.) Deposits Extent:
Infiltration: **None** Pipe Seal Cond: **Sound**
